Single Equipment Full Report

For: **BC-1 Distillate Pump**

Measurements from 2017-12-14 to 2018-04-07

Generated On **2018-05-08**

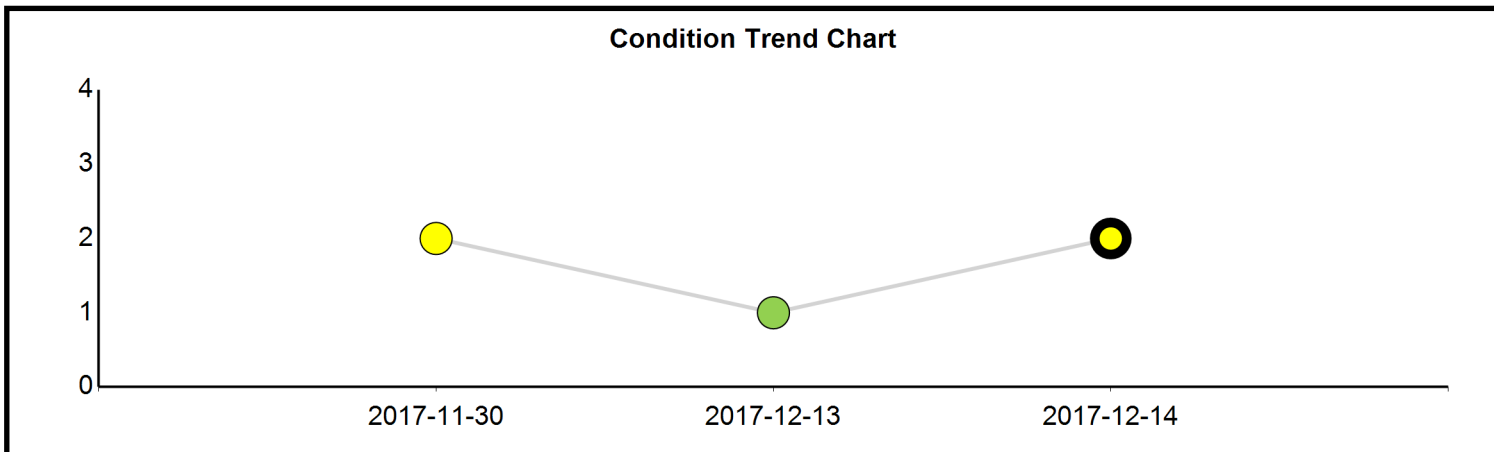
Condition and Recommendations

For Measurements done	Condition
From 2017-12-14 to 2018-04-07	(2) Initial Fault detected (P)

Overall velocity levels were acceptable this survey (5.7mm/s RMS at NDE), with the dominant vibration primarily at shaft rotation speed. Rotational vibration levels have remained relatively stable since the last survey (22 Dec 2015). Very low level vibration at 231Hz was evident, which may indicate an initial defect on the NDE bearing inner race. This has remained stable since last survey. The sensor at the drive end was giving a faulty signal.

Action	Failure Type	Failure Mode	Severity	Action Type	Urgency
Monitor for any further deterioration in balance or bearing condition.	SPO	BRF		FA	ANO
Inspect sensor on DE bearing and repair/replace as required.	SYS	BRRRD		LE	AWC

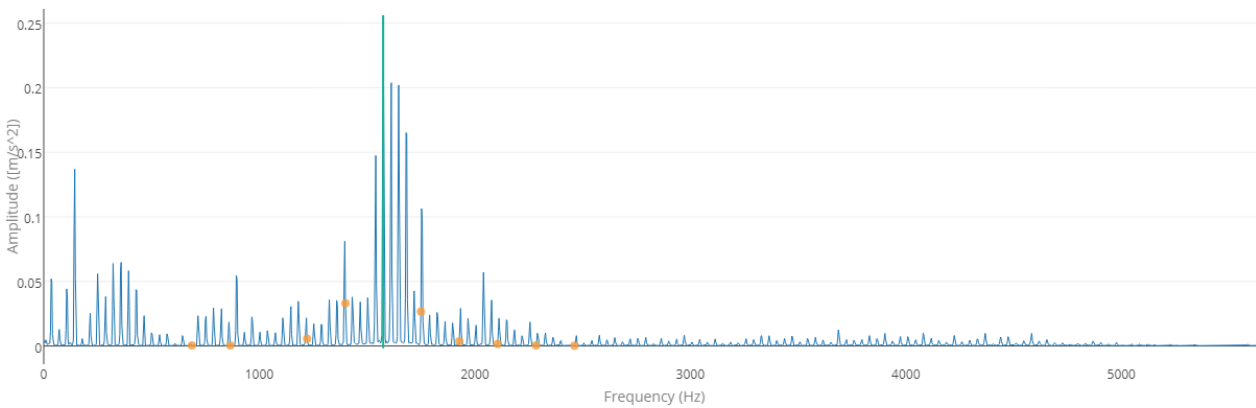
4841_Acceleration.jpeg

Acceleration spectrum for BC-1 Distillate Pump for data collected on: 2017-12-14 01:56:36

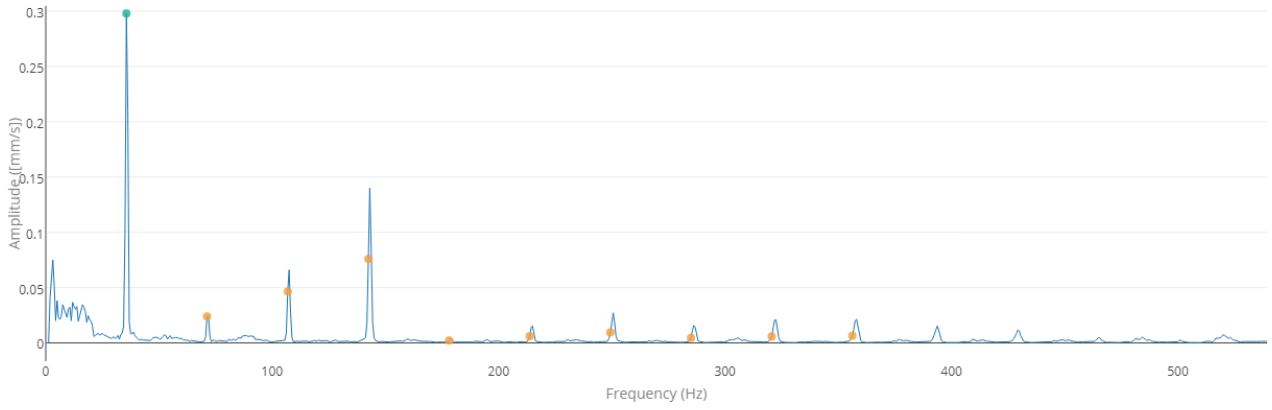
4838_Velocity.jpeg

Velocity spectrum for BC-1 Distillate Pump for data collected on: 2017-12-14 01:56:36
