Single Equipment Full Report

For: **BC-1 Distillate Pump**

Measurements from 2017-12-14 to 2018-04-07

Generated On **2018-05-08**

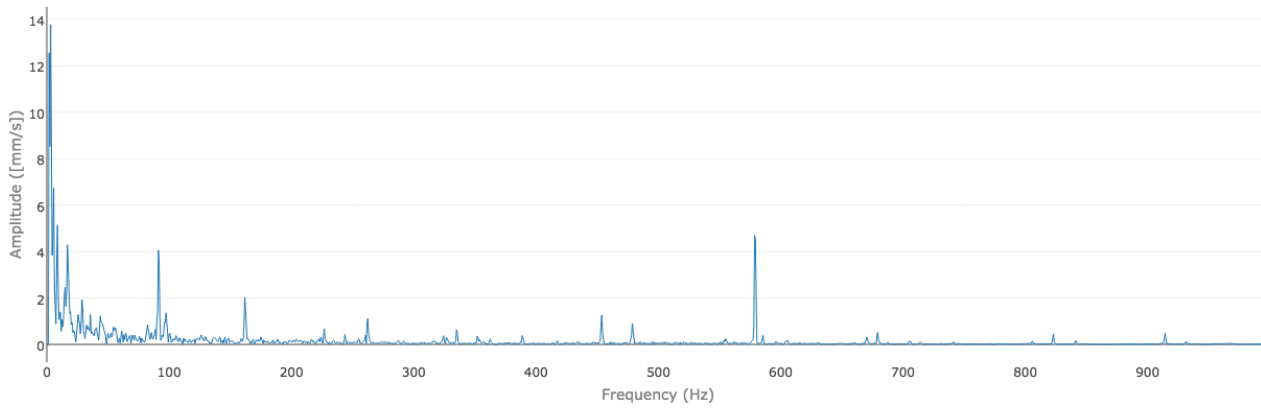
1H- Motor NDE Horizontal (AVDT)

Overall velocity levels were acceptable this survey (5.7mm/s RMS at NDE), with the dominant vibration primarily at shaft rotation speed. Rotational vibration levels have remained relatively stable since the last survey (22 Dec 2015). Very low level vibration at 231Hz was evident, which may indicate an initial defect on the NDE bearing inner race. This has remained stable since last survey. The sensor at the drive end was giving a faulty signal.

Action	Failure Type	Failure Mode	Severity	Action Type	Urgency
Monitor for any further deterioration in balance or bearing condition.	SPO	BRF		FA	ANO
Inspect sensor on DE bearing and repair/replace as required.	SYS	BRRRD		LE	AWC
